The Barns at Balderdash Cellars

WHEN OUR LOCAL WINERY, Balderdash Cellars, purchased an old farmstead in Richmond, Massachusetts, for their new home, the property sported an L-shaped barn complex. It was comprised of four distinct structures: two 26x37, three-bay English threshing barns, an 18x30 horse barn purported to have been relocated from the nearby Hancock Shaker Village, and an 18x27 connector at the junction. However, the complex had a mostly nonexistent foundation and many decayed or missing pieces, and would require some heroic measures to save it. Disassembly of the barns was the only effective way to repair the structures. The two connected English barns would be great as a seasonal event space for a winery hosting weddings, concerts, and similar get-togethers. The Shaker barn would go into storage for future use on the property, and the connector, a late-19th-century cobbled mess, would be recycled.

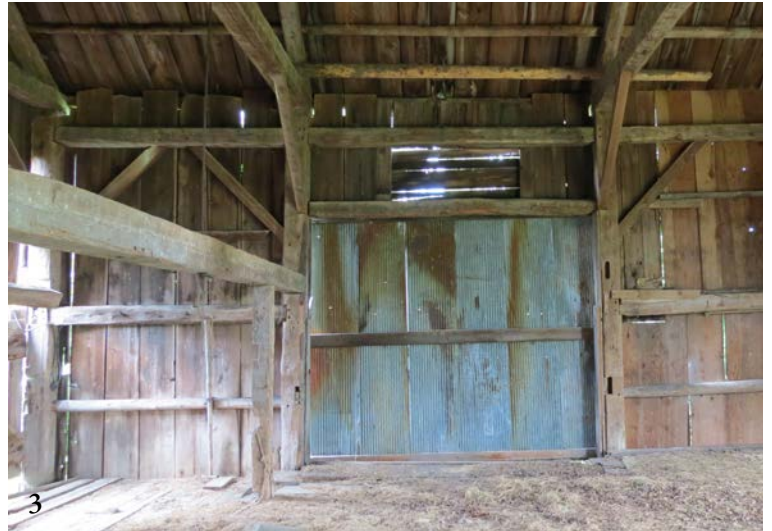
Another historic, common purlin barn surveyed in Newbury, Vermont (Fulton barn, ca. 1830), is configured in plan like a common threshing barn but with full-length ties that extend over the tops of eaves-wall posts (Fig. 3). The plates are segmented and tenon into the sides of eaves posts like the aisle barn type. This barn, too, has survived well, despite serious neglect.

3 A Newbury, VT, threshing barn probably built for the Fulton family circa 1830. An uncommon, resilient frame design using segmented and flying plates, and common purlin roof framing.

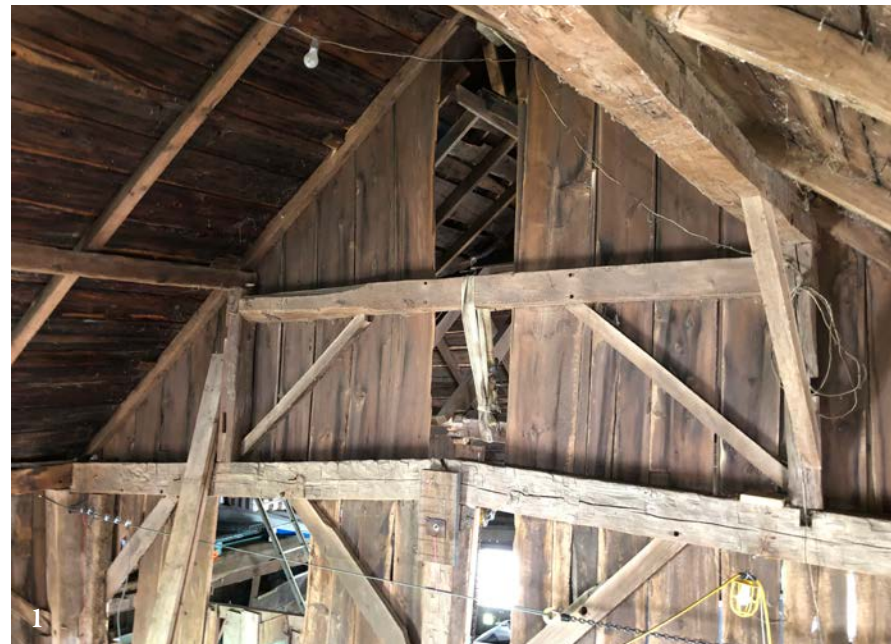
1 The west gable of the 1794 barn illustrates the condition of the barn as found. It was definitely in need of some help. The wider, lower braces were riven, the upper braces up-and-down sawn.

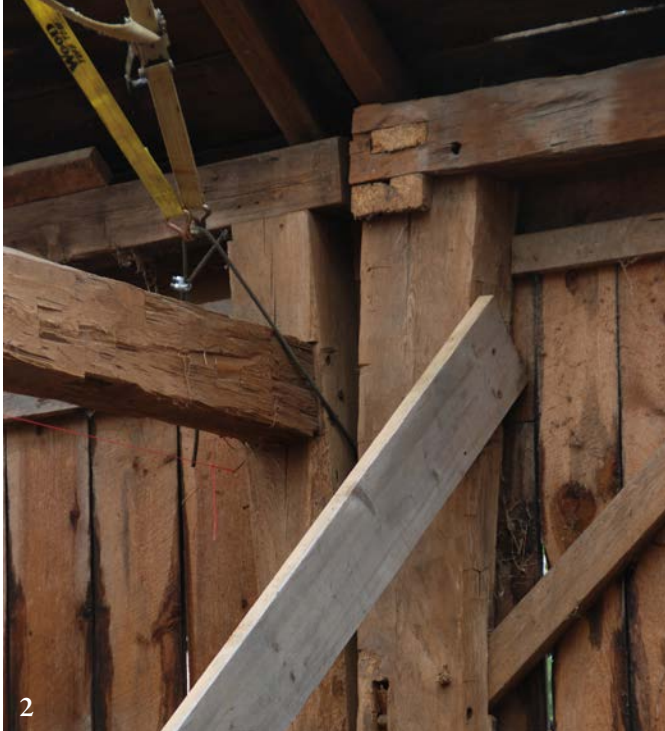
2 Photograph by David E. Lanoue, Inc.

2 Looking at the south wall where the two English barns abut, one can see the 1794 scribed barn on the right with its tapered post and triple bypass joint. Much of the east end-wall framing had been removed long ago. The 1832 square-ruled barn with its dropped tie beam is on the left.

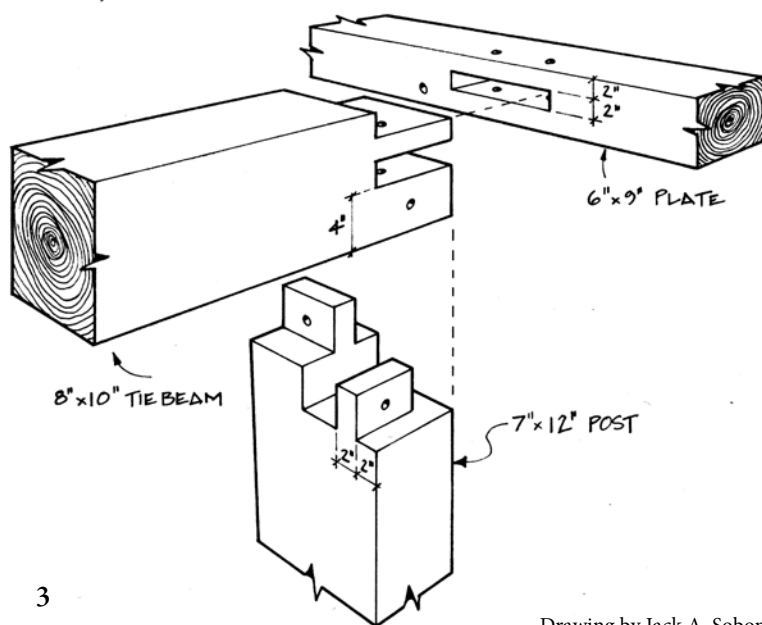
3 Drawing by Jack A. Sobon

3 The barn features eight triple bypass joints in its construction. A tapered post, wide end up, is placed flatwise against the longitudinal wall and has a tenon for both the plate and tie beam. The tie beam engages the plate with a tenon as well. For more on this joint, see my *Historic American Timber Joinery* (2014), p. 19, or *TF 56*, p. 16.

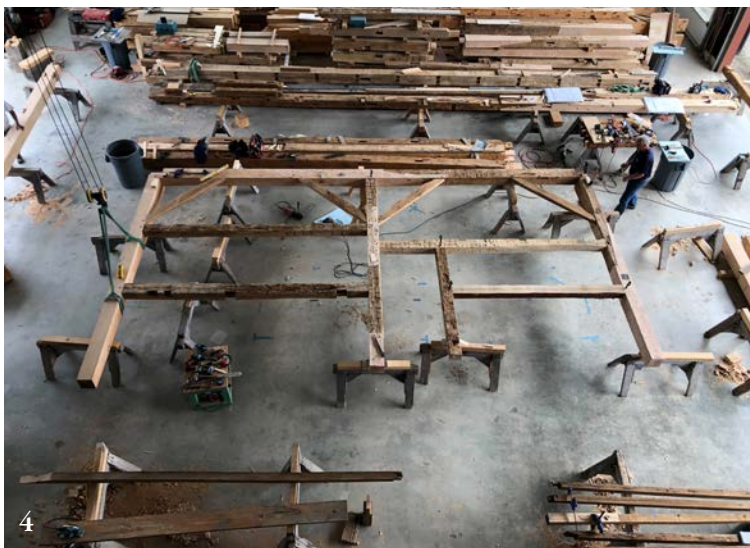
4 Photograph by David E. Lanoue, Inc.

4 To effectively repair a scribed frame, the sections should be laid out level as they were originally scribed and the new components similarly scribed in place. Here is the western gable frame of the 1794 barn with an original gable-wall door (unusual in English barns) set up in the shop.

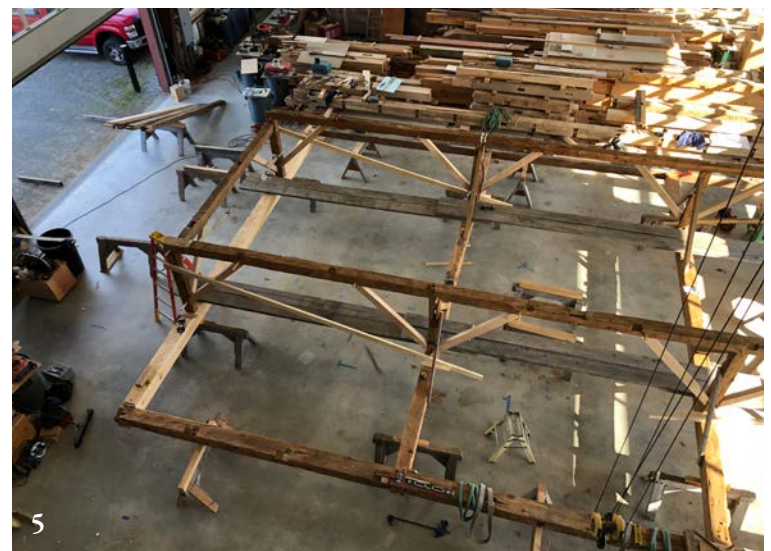
5 Photograph by David E. Lanoue, Inc.

5 The frame, from the plates up, was assembled in the shop. The new gable tie beam can be seen at left. The purlin plate in the foreground is a reused plate from an earlier English barn with the standard English tying joint. Note the half dovetail on its top. Originally, only the end posts had purlin plate braces but I deemed the additional support necessary for the undersized purlin plates.

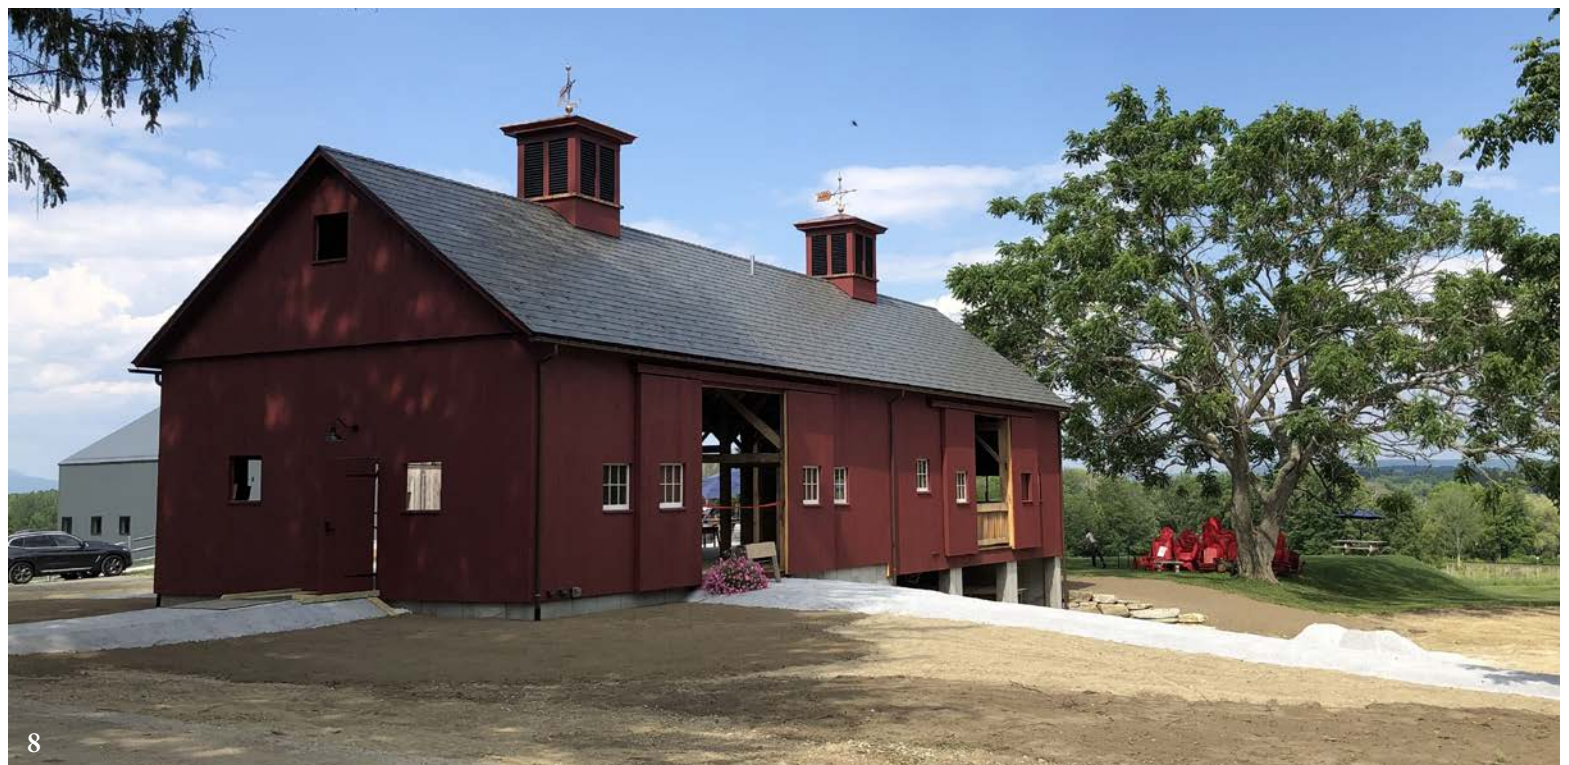
8 The restored barn, with landscaping yet to be finished, stands proud once again. The outer layer of boarding is new pine, stained to match the original color.
